Course Car Lights and Sirens

Rally Sport Ontario
May 3, 2010

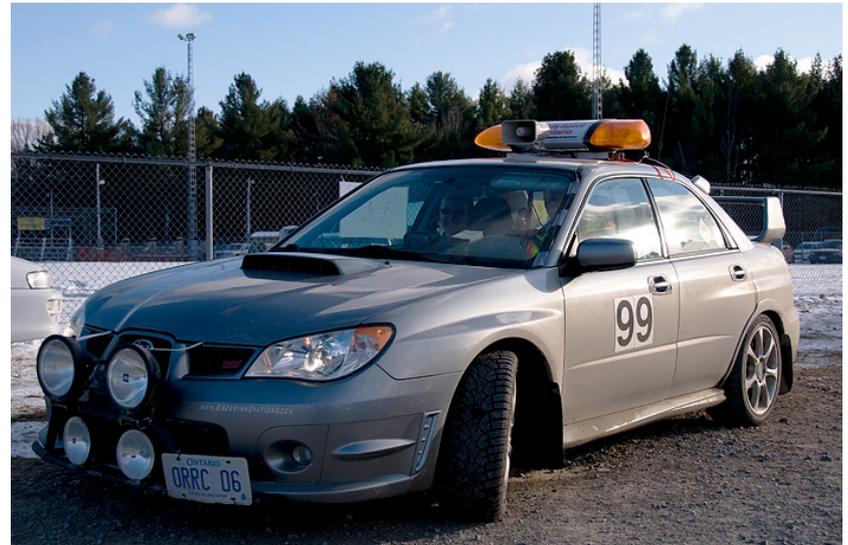
- Six assemblies in varying states of repair
- Four full size light bars and two strobe bars
- Full description found in Appendix

- Many issues with current systems:
 - Under rated wiring, no fuses, insufficient lengths of wire, under rated switches
 - Broken and missing mounting parts and straps
 - Sirens not working (2)
 - Missing control boxes (2)
 - Thanks to Peter G, Mark and Christine for the evaluation.

- Current equipment: make necessary repairs, schedule periodic evaluation and maintenance, deal with storage issues
- Purchase small number of in-car equipment for further evaluation

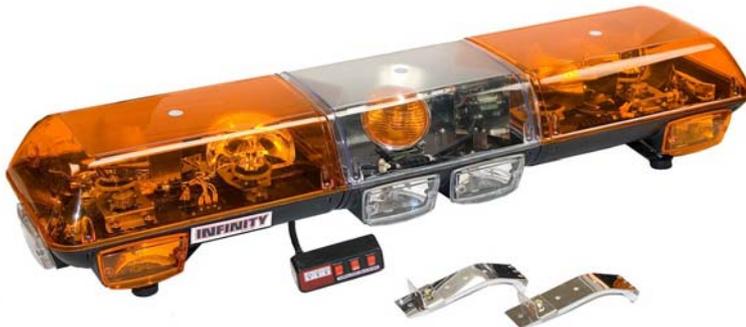
Replacement Option – Integrated Light Bars

- Address all maintenance and systemic issues
- clean appearance and outstanding performance
- Modern wiring and switch gear (LED)

- Requires proper storage and maintenance
- VERY expensive (\$2500 - \$5000 each!)
- Must be permanently mounted to car or affixed to rack system (different for each car \$250)

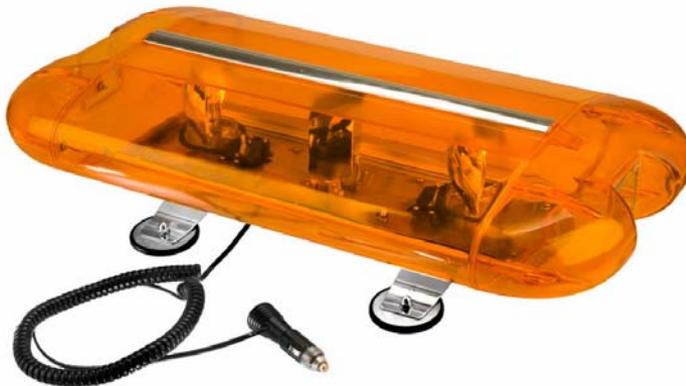
Replacement Option – Non-integrated Light Bars

- Less expensive
- Small, lighter (LED)
- Simple mounting
- Good performance

- Costly (\$350 to \$600 each)
- Generally magnetic mounts only
- No siren provisions
- No wiring or switch gear provided (varies)

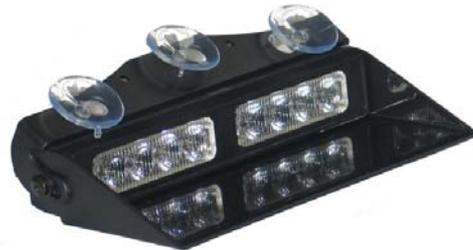
Replacement Option – Interior Mount Lights

- Simple, light
- Easy to move between cars
- Various mounting options (windshield, sun visors, etc)
- Fair performance
- Very low power draw (LEDs)
- “stealth”

- No sirens
- Requires multiple accessory plugs
- Questionable mounting
- Costly (\$250 to \$500 each)
- Requires at least two per car
- Limited range (especially at night, very directional)
- “stealth”

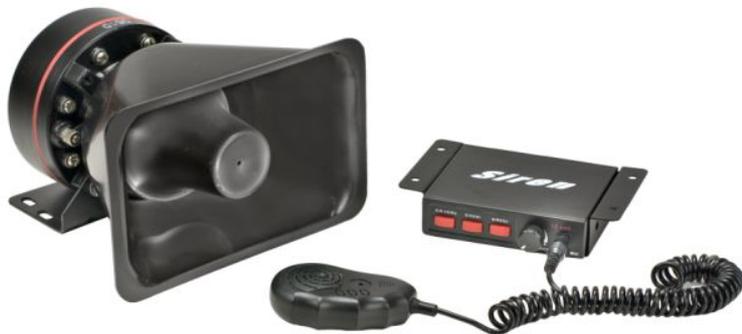
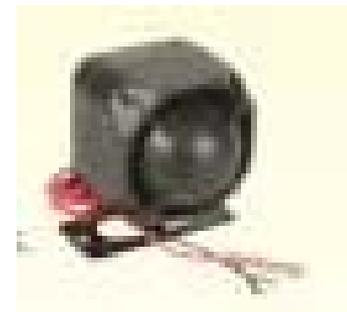
[Replacement Option – Sirens]

- Integrated
- Non-integrated:
 - Commercial (\$300 to \$700 each)
 - “Budget” (\$7 to \$100)

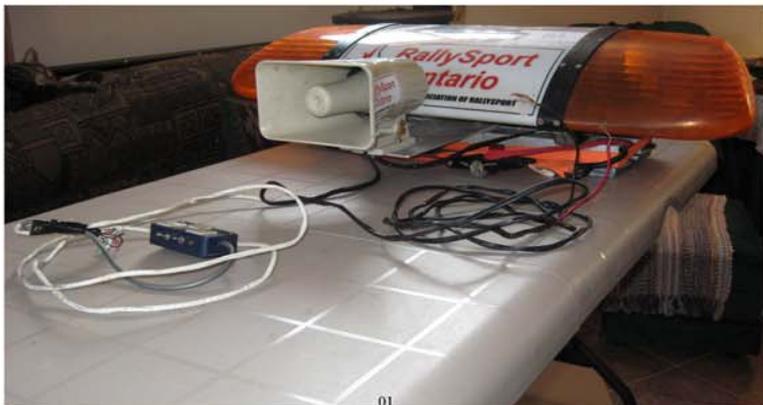
ID Number	Light Info	Horn Info	Mount Style	Wiring	RSO Lights		Switches
					Wire length	Wire Type	
01	Hella OWS 2RL007900 12VDC 55W/ 24VDC 70W Working	PowerHorn two sound 6-12VDC 115dB@1m Working	Ratchet Strap, aluminum base With duct tape anti scratch	Black – T90 12AWG (600V) Red – T90 14AWG (600V) Cable – Cat5E Patch Cable Cable – Belden 9502	Switches – 89" Power – 130"	Cat5E from lights to Switch Box multi-wire Red & Black wires wrapped with electrical tape	Led's no longer working SW1 – next to Amber Light SW2 – next to Green Light Common – White Common – Red NO – BK NO – BK
02	Federal Signal JetSonic Working	Incorporated into lights Not Working	Metal Base with 3 1/2" Suction Cups Hold down strap	Black – T90 12AWG (600V) Red – THHN 12AWG (600V) Cable – Cat5E Patch Cable	Switches – 120" Power – 153"	Cat5E from lights to Switch Box Red & Black wires with tywraps 4-6" apart and a 20A fuse on Red	Led's connected SW1 – Lights SW2 – Horn PB – horn warble

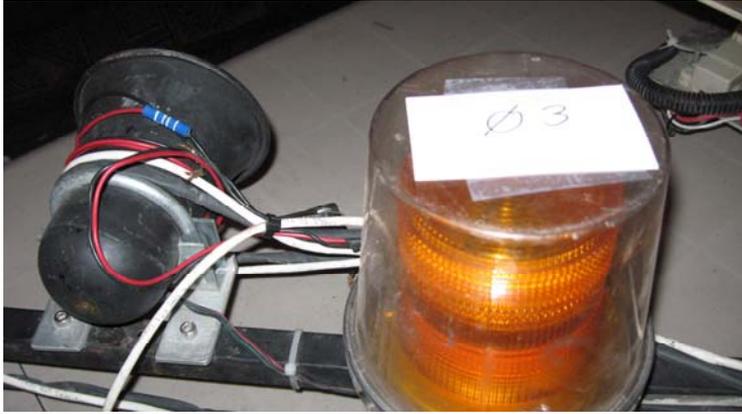
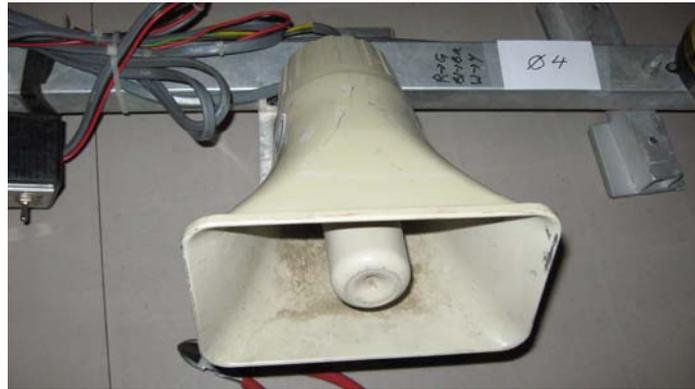
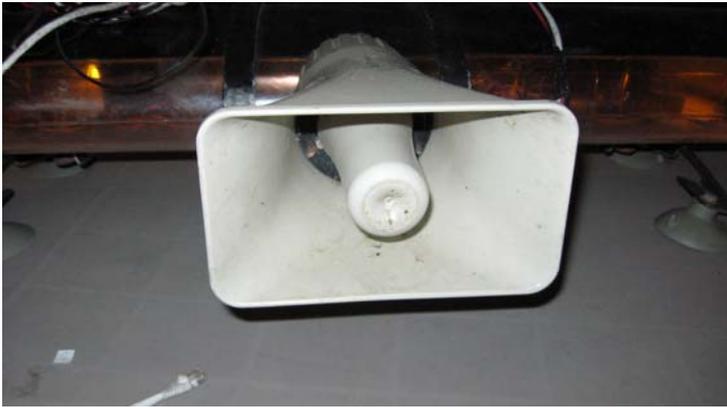
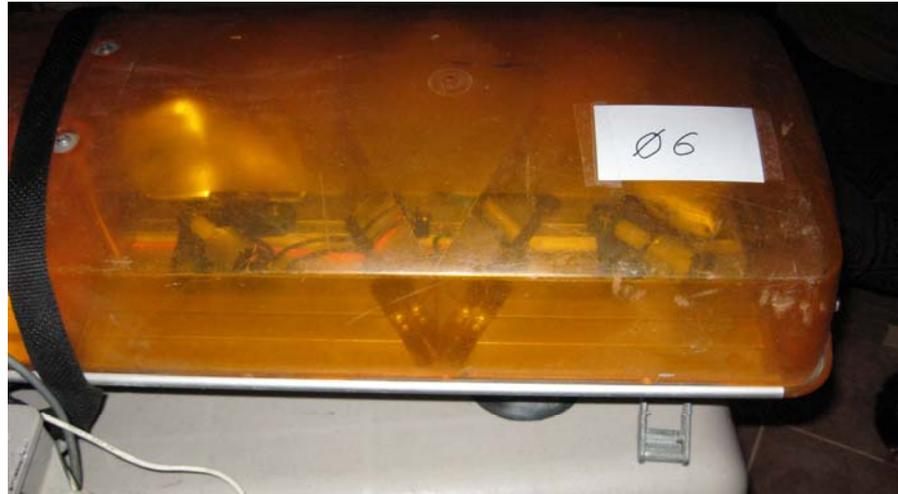
[Appendix]

03	Lantern Co Star Head Light Strop 200J-1 12V 0.5A Working	Horn – unknown make Working	Roof Rack and Strap No pads on feet which are hard plastic	Black – TR-64 16AWG (300V) Red – TR-64 16AWG (300V) Cable – Cat5E Patch Cable	Switches – 125" Power – 164"	Cat5E from lights to Switch Box Red & Black wires with tape 4-6" apart and a 10A fuse on Red	Switch box missing Used from #2 for testing
04	Radio Shack Security Strobe Working	PowerHorn two sound 6-12VDC 115dB@1m Working	Aluminum base with hard feet No straps present	Black – low voltage wire Red – low voltage wire Cable – grey outer 12AWG 3 wire BR/GN/YE	To Box – 67" From Box – 110"	Grey Cable and Black and Red wires Grey Cable Positive – White butt connected to Green and Yellow wires Negative – Red butt connected to Brown wire	No LED's on box Connections are soldered with no protection from shorting
05	Federal Signal Model J Series A Working	PowerHorn two sound 6-12VDC 115dB@1m Not Working	Steel Base, 4 suction cups No straps present	Black – T90 12AWG (600V) Red – THHN 12AWG (600V) Cable – Cat5E Patch Cable	Switches – 128" Power – 180"	Cat5E from lights to Switch Box Red & Black wires connected to 12V cigarette Adapter 25A fuse on Red	Switch box missing Used from #2 for testing Note – 12V cigarette adapter with 13" lead was not properly connected to wires.

06	Star Warning Systems StarBar Strobe Working	Radio Shack Dual Sound Alarm 12V 550mA 105dBa Working	Aluminum Base with suction cups Hold down strap	White – RWC 14AWG (600V) Black – RWC 14AWG (600V) Cable – Belden 9502	White – 214" White – 214" Black – 205" Cable = 180"	With 20A fuse With 20A fuse	Yellow plastic denotes Horn Wrapped together with electrical tape
